Report of the  
**PRESIDENTIAL  
COMMISSION**

*on the Space Shuttle  
Challenger Accident*

June 6th, 1986  
Washington, D.C.

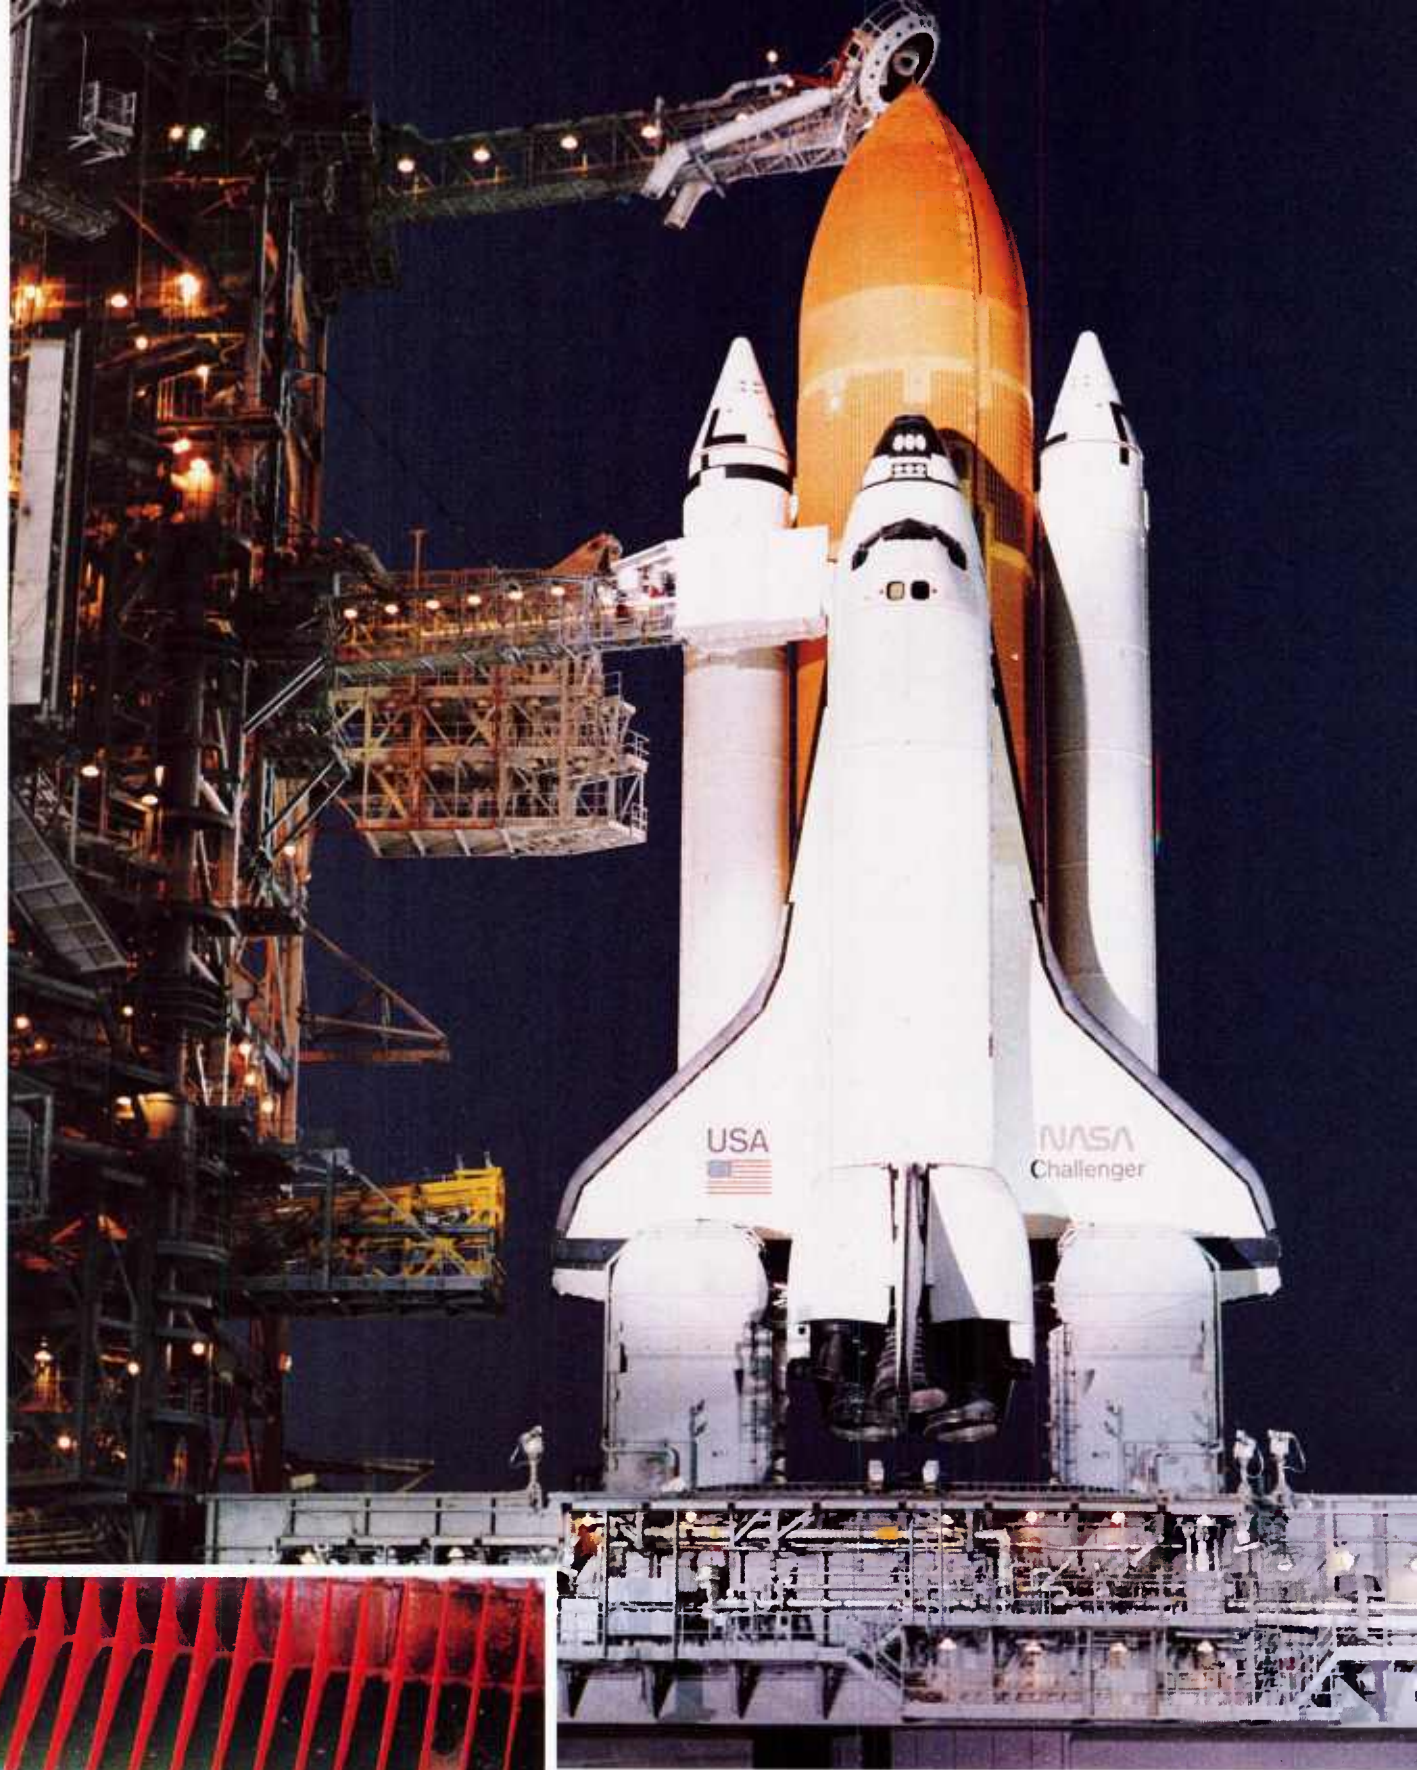
Above, Shuttle 51-L on Kennedy Space Center Pad 39B in the early morning of launch day. Temperatures were well below freezing, as indicated by the lower left photo, which shows thick ice in a water trough despite use of an anti-freeze solution.

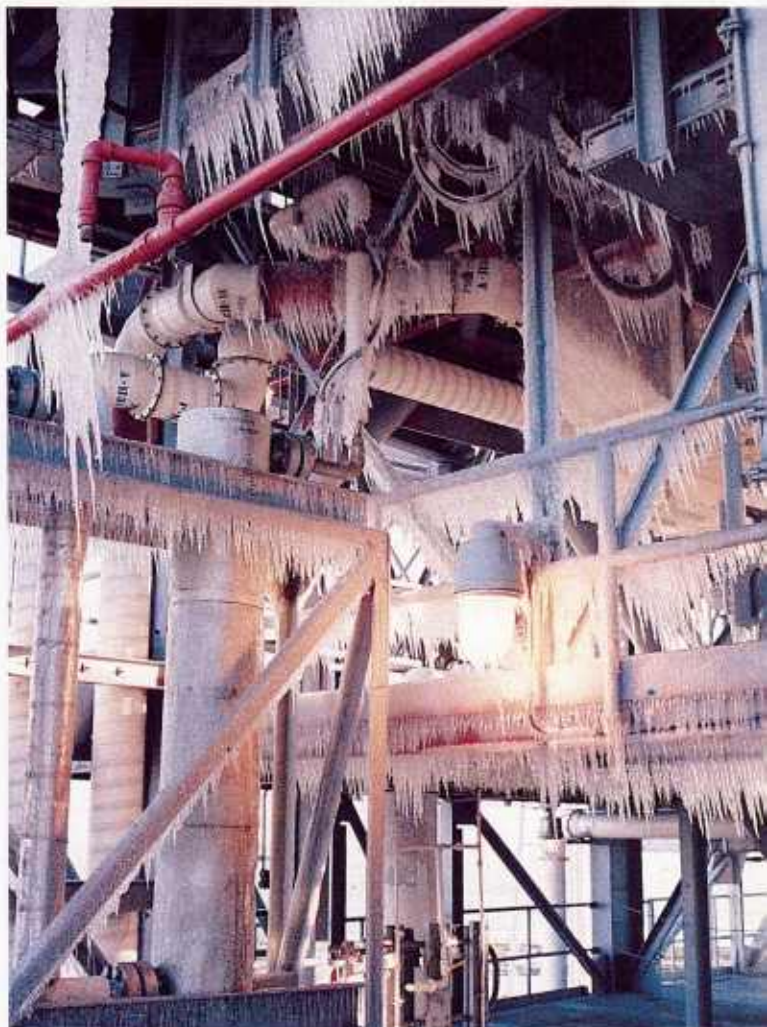
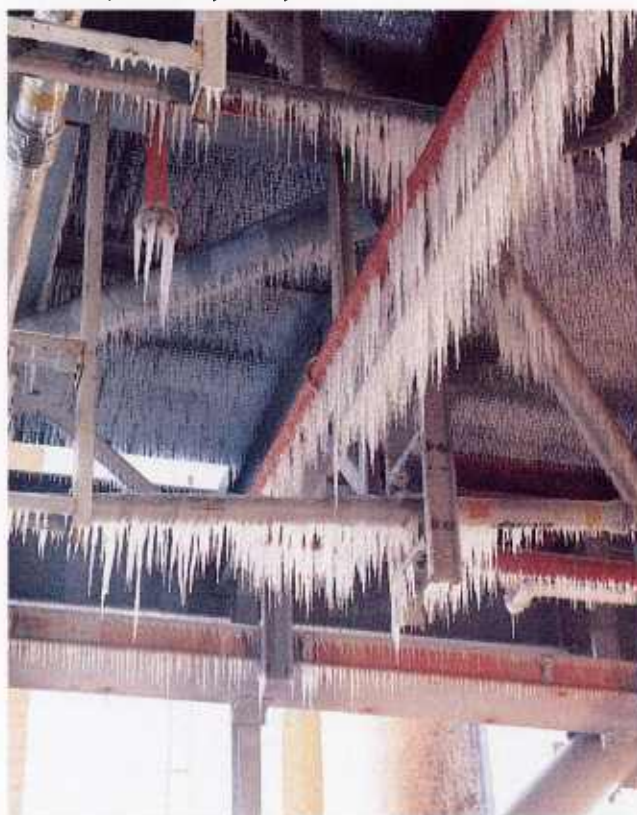
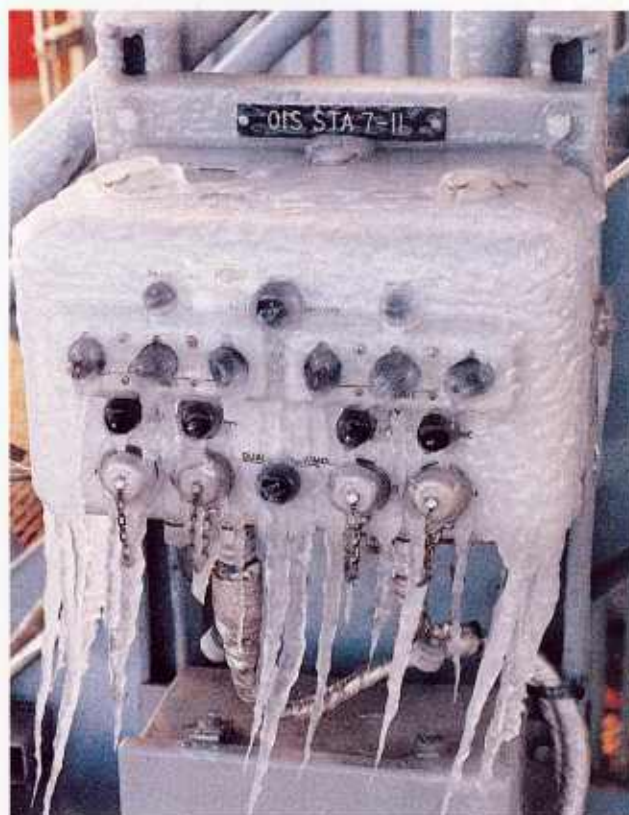
Above, foot long icicles on a lower level of the Fixed Service Structure frame the attachment point where the Orbiter is attached to the external tank (arrow). Icing was even more extensive at upper levels of the service structure (upper right and below). At right below is a ground communications box (not used during launch) rendered inoperable by heavy ice.

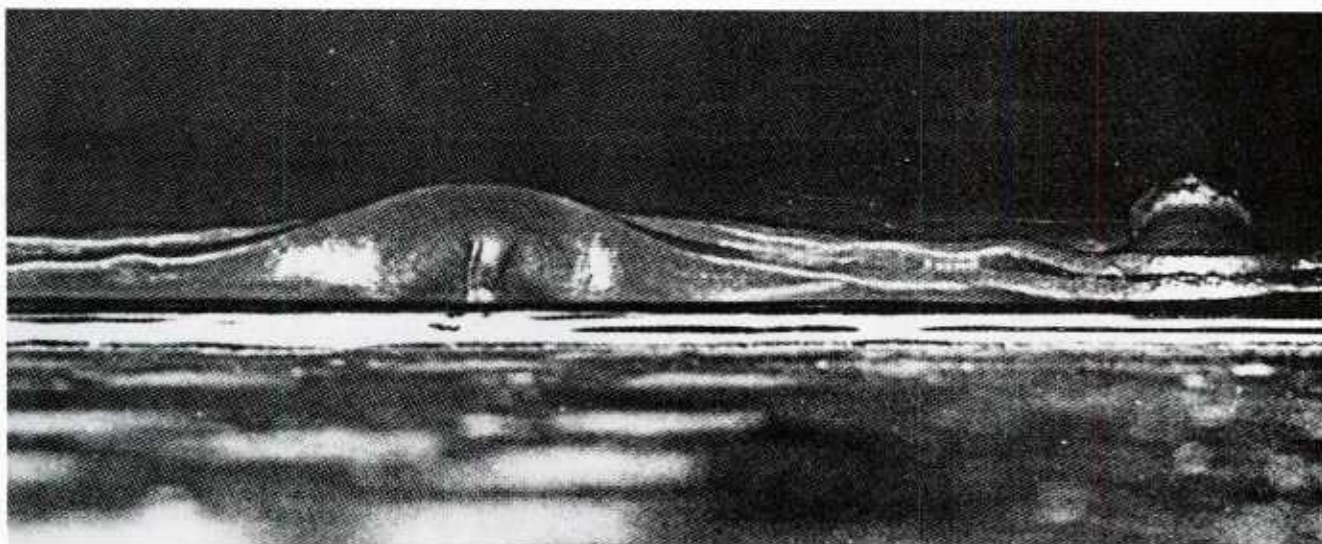
Pressure tests at 200 pounds per square inch of the Solid Rocket Booster joints produced bubbles in putty used to line the joints.
